INDOOR AIR QUALITY ASSESSMENT Odor Investigation

**Executive Office of Elder Affairs
One Ashburton Place, 5th floor
Boston, MA**

Prepared by:
Massachusetts Department of Public Health
Bureau of Environmental Health
Indoor Air Quality Program
December 2016

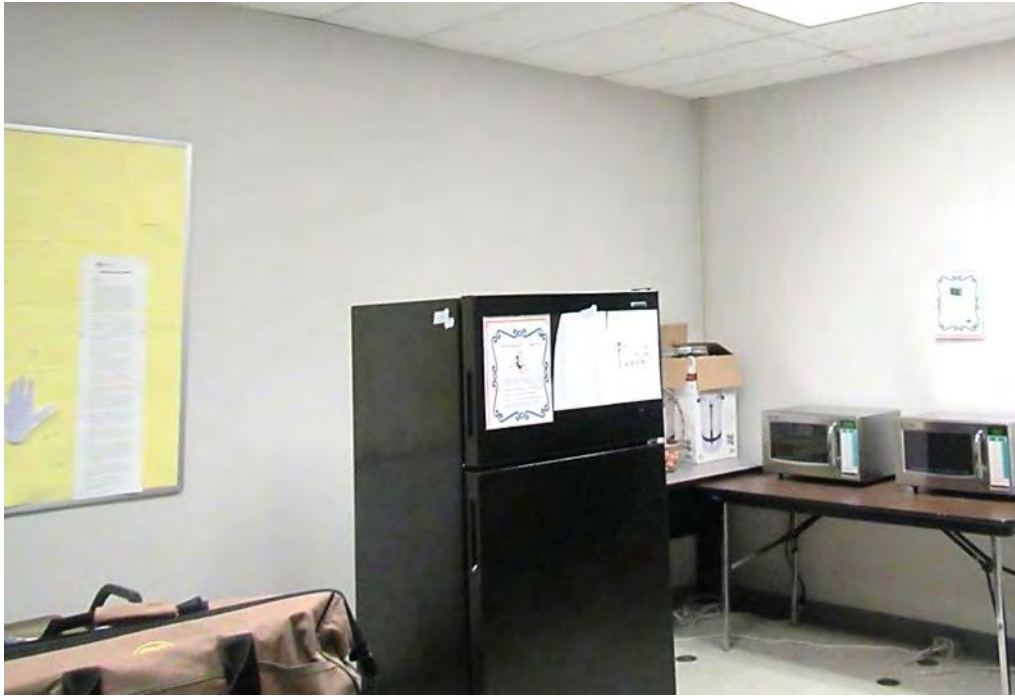
Picture 1

The reason for the requested visit was to investigate the site of a spill or leak in the staff lunchroom. Several weeks previous to the visit, there had been reports of a spill or leak behind the refrigerator in the staff lounge (Picture 1). An odor was reported and there were concerns that mold had colonized the area behind the refrigerator.

Staff lunchroom with refrigerator pulled away from the wall

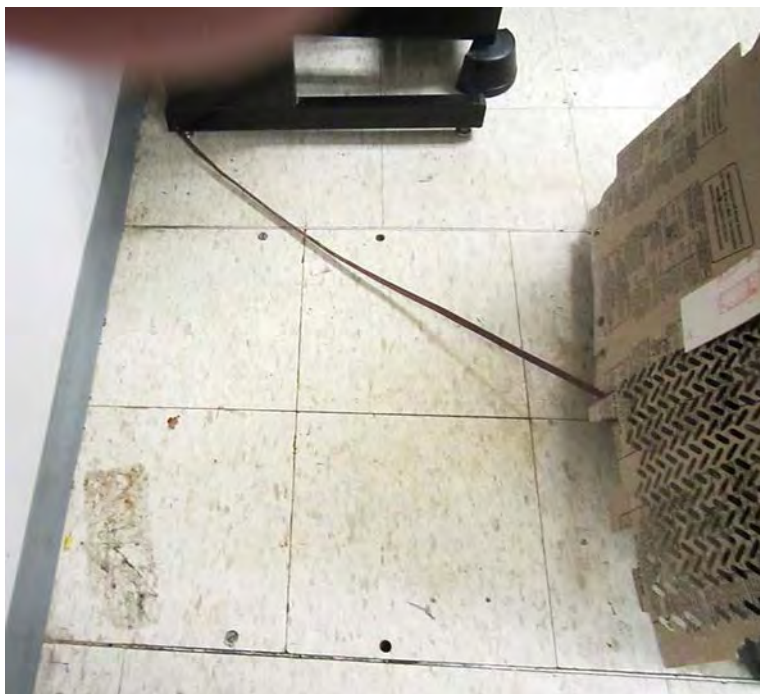
Picture 2

The refrigerator was pulled away from the wall and the wall behind it was examined (Picture 2). The wall, including the space underneath the coving, was dry. There were no musty or moldy odors. It was reported that an odor had persisted until thorough cleaning of the area had been conducted. Note that the floor in this room is tile, which is not prone to growing mold,

although dirt or debris on the tile floor can become colonized. Some sticky material was seen on the floor underneath where the fridge had been; this material should be cleaned.

Water streaks were observed on part of the wall behind the fridge, which should be cleaned. It was also reported that some water-stained tiles had been removed since the leak. Although the area above the ceiling tile system in this building contains a large open space and no porous materials that might collect water or grow mold, stained ceiling tiles should be removed whenever a leak occurs in part to enable faster detection of any new leaks. The US Environmental Protection Agency (US EPA) and the American Conference of Governmental Industrial Hygienists (ACGIH) recommends that porous materials (e.g., wallboard, carpeting) be dried with fans and heating within 24 to 48 hours of becoming wet (US EPA, 2008; ACGIH, 1989). If porous materials are not dried within this time frame, mold growth may occur.

Area behind refrigerator, note darkened sticky patch

1. Clean the sticky material from the floor underneath the fridge.
2. Wash off the wall behind the fridge to remove water stains.
3. If leaks reoccur, ensure that all moistened materials are dried or removed within 24-28 hours, per EPA recommendations (US EPA, 2008; ACGIH, 1989)
4. Continue to keep the refrigerator and other food storage and preparation areas clean to prevent odors and pests.
5. If floor tiles are to be removed and replaced, ensure that good work practices are followed to prevent dusts and odors from impacting occupied areas. The guidance “Methods Used to Reduce/Prevent Exposure to Construction/Renovation Generated Pollutants in Occupied Buildings” is attached as Appendix A for reference and can also

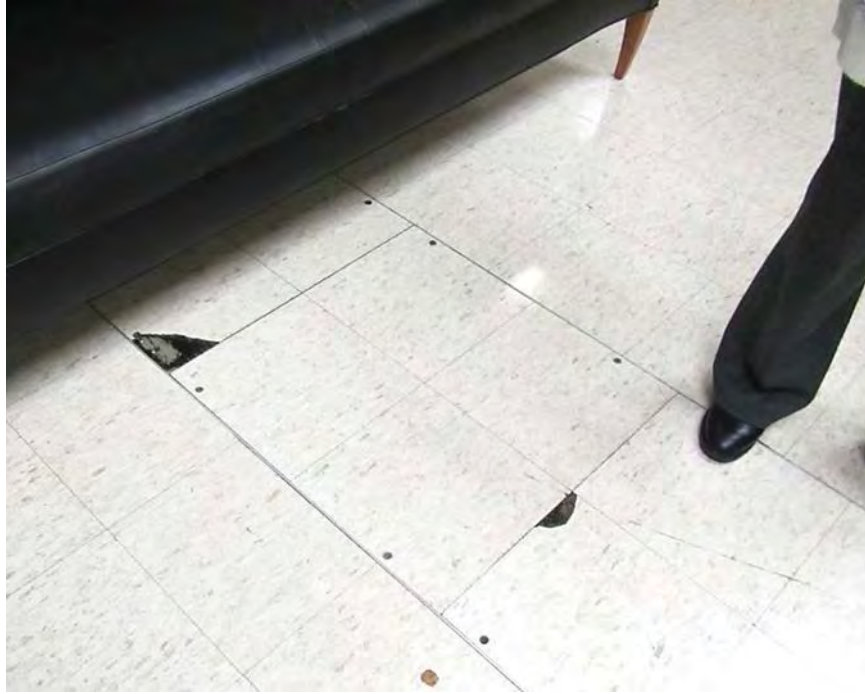
Picture 3

Note that the flooring in this room is original to the building and is in somewhat poor condition (Picture 3) and is scheduled to be replaced. In general, areas with water and food use, such as lunchrooms, should have non-porous flooring.

Poor condition of floor tiles
